Program Summary:

Historic restoration and transformation of a tragically deteriorated and inaccessible single-family French Quarter property into a mixed-use lifestyle destination.

619 Royal Street, built in 1795, included the full historic restoration of an overgrown and overlooked 4-story French Quarter townhouse. Concealed by years of insensitive patchwork, the historic architectural integrity, circulation, and synergy have been revived throughout the retail and residential spaces.

HISTORIC FRENCH QUARTER TOWNHOUSE

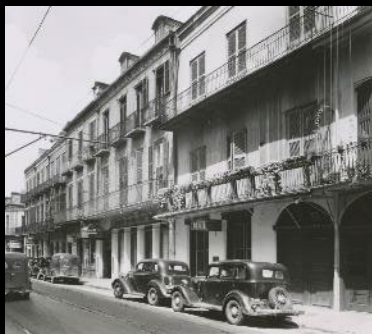
1939

Over time, the building experienced insensitive repairs and eventually fell into tragic disrepair.

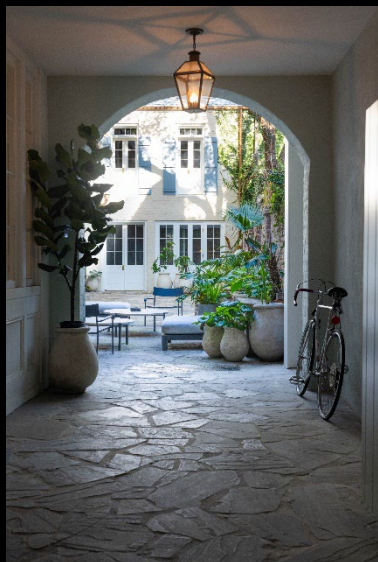
CARRIAGEWAY
Looking towards courtyard

- Flagstone pavers connect the carriageway to the courtyard and interior stair.
- A wooden storefront in the carriageway provides a glimpse of the interior townhouse stairs and serves as wayfinding to enter the townhouse.
- Mirrors were incorporated along the stairwell for a dramatic ascension to the upper floors.

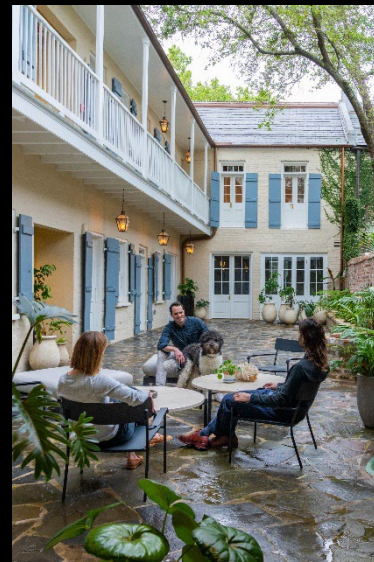
COURTYARD
Looking to the rear wall

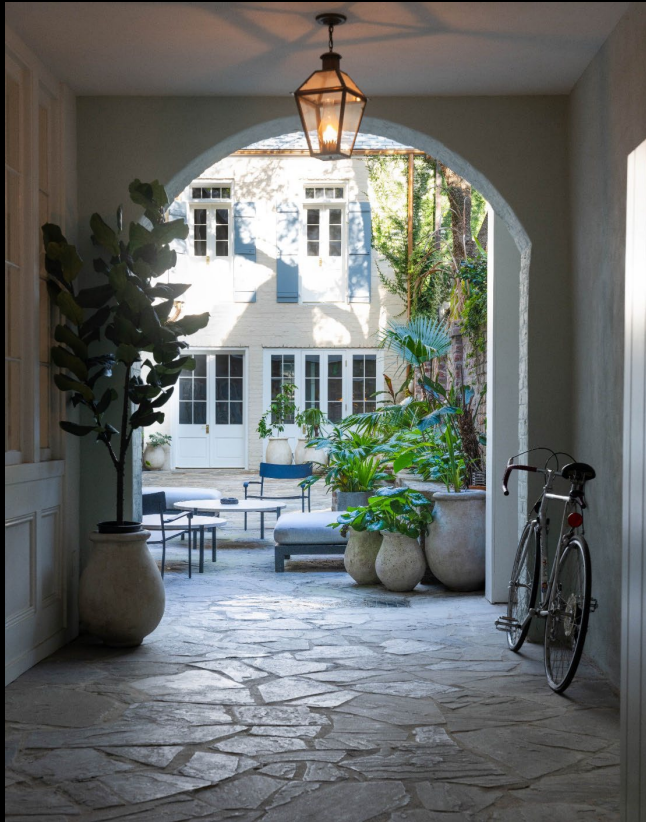
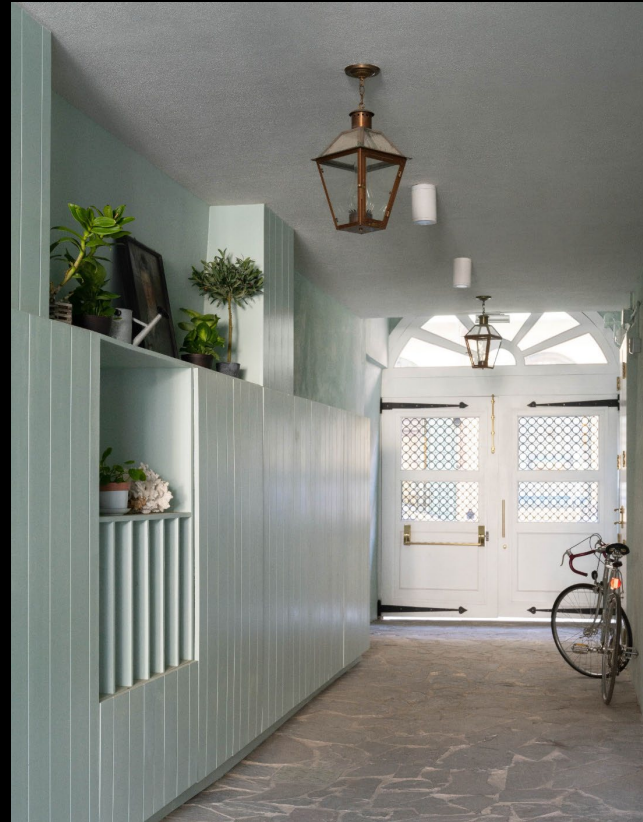
The carriageway now serves as a main artery through the property for both retail and residential tenants. The archway was rebuilt, and new street-facing doors installed.

The doors can be either completely open for patrons or closed off with single door access for residents.

New flagstone pavers replaced concrete providing an inviting path into the courtyard through the new doors.

New paneled millwork was carefully designed to house utilities and storage.

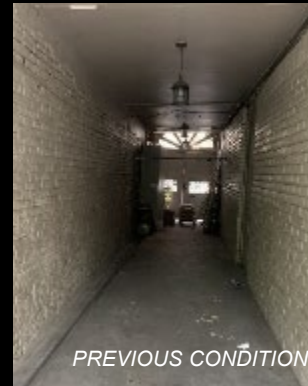
Most recently used for forgotten storage, the carriageway disguised a settling floor structure above and housed outdated utilities.

Original openings had been covered with a modern-day brick veneer wall leading into the townhouse.

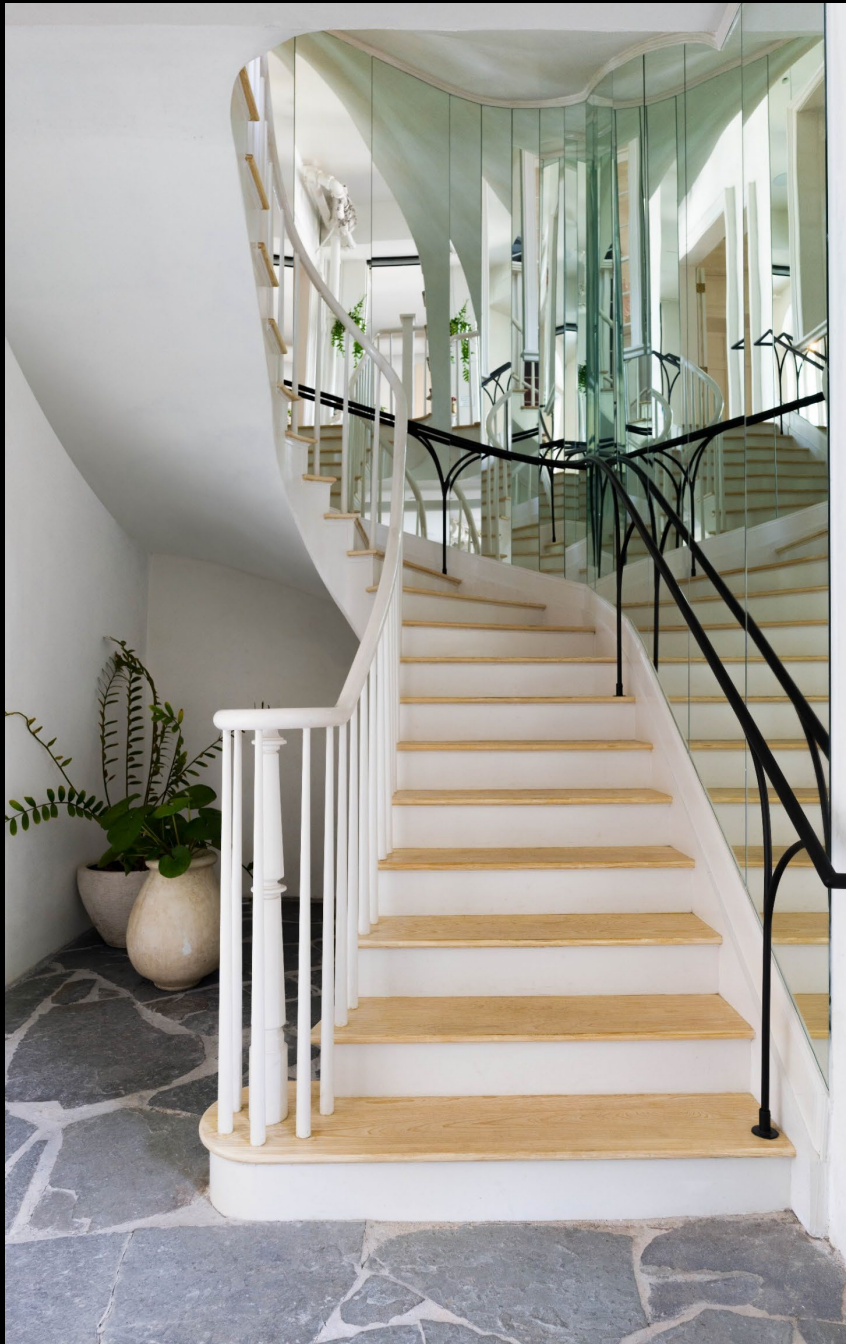
The historic stairwell recreates a “light and airy” visual connection at each floor, starting at the carriageway.

For a dramatic ascension, the stairs were rebuilt and reflective mirrors along the curve wall were incorporated for a glimpse of movement.

A new skylight allows light to pour into the space.

Delicate, custom fabricated metal handrails serve as a simple contrast to the light reflecting walls, and compliments the historic wood railing.

The new and existing treads were carefully finished to match and provide a modern and light feel to the stairwell.

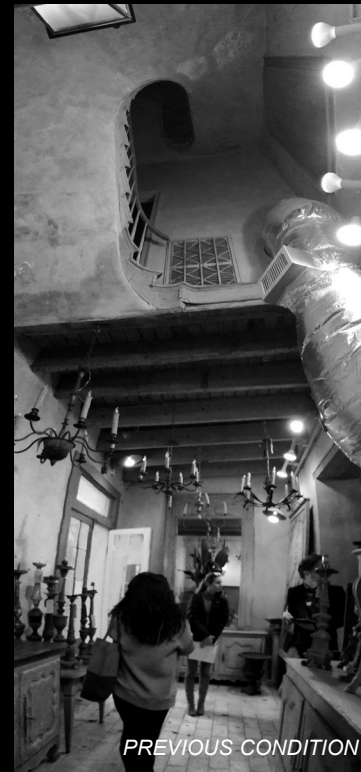
PREVIOUS CONDITION

The 1st floor stairwell was removed at one point and portions closed off by walls, making it dark and uninviting.

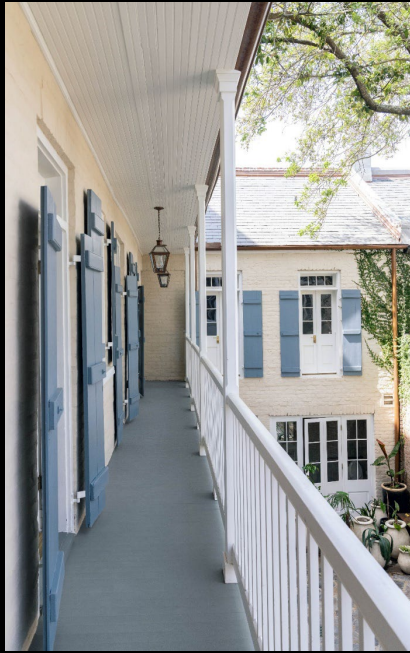
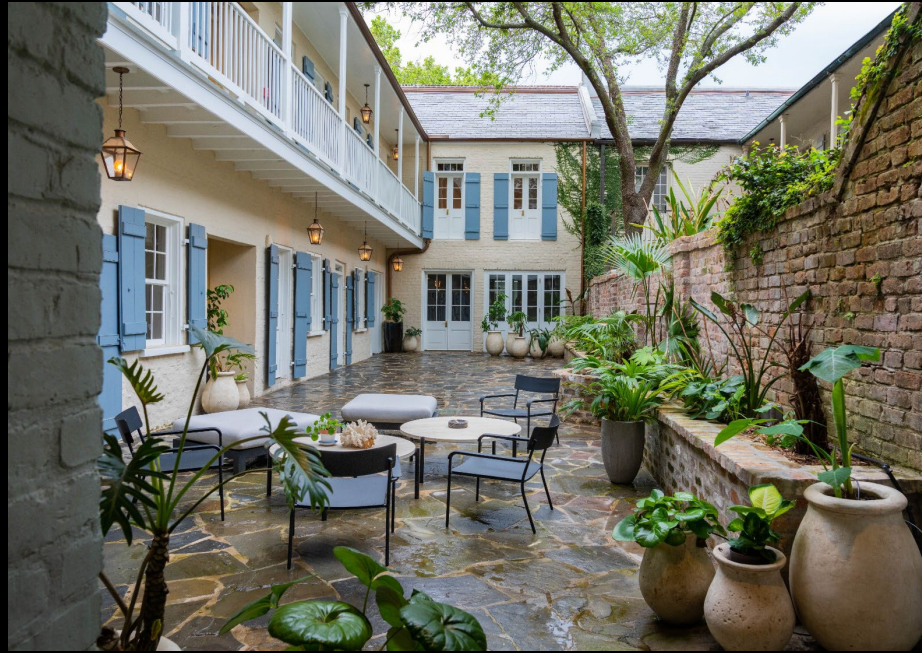
The gallery and railings were structurally unsound.

The rear servants' quarter wall had deteriorated due to overgrown vegetation and settlement.

The wall was completely rebuilt, and the openings re-designed, taking cues from what would have been historically appropriate for the facade.

Once vegetation was removed from courtyard wall, the architect discovered structural instability and poor design.

It was partially rebuilt to incorporate new pilasters, a new foundation and planter.

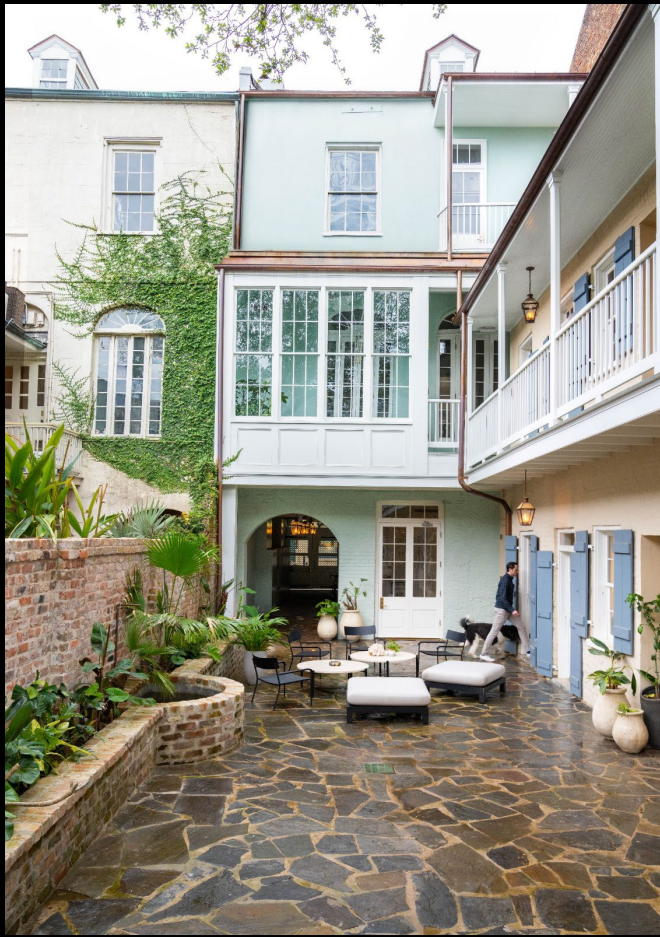
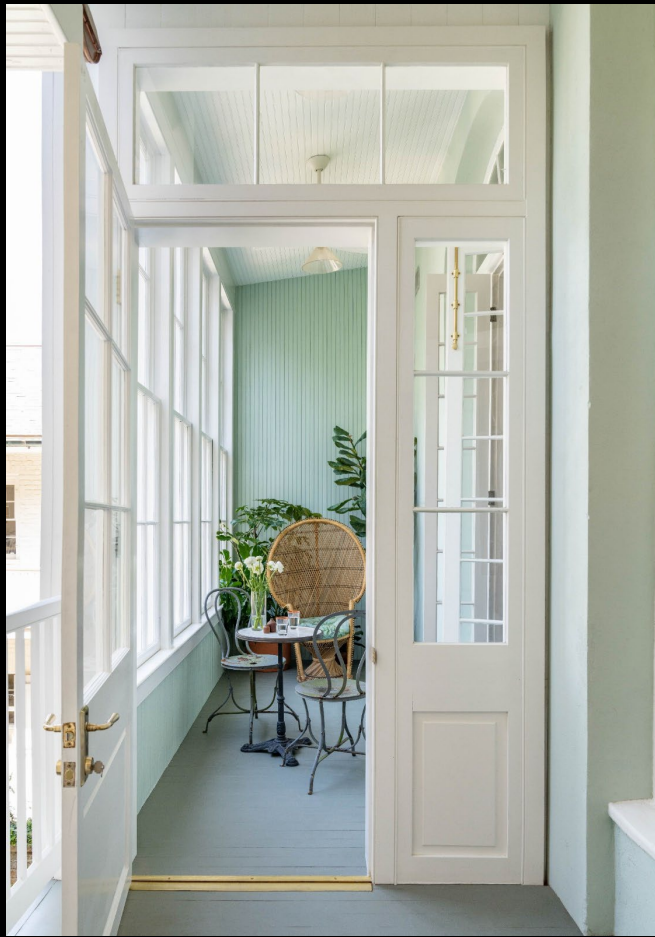
The existing sunroom was clad with low-quality siding and one of many haphazardly constructed infills observed throughout.

It is now an oasis for lounging, accessible from the townhouse or the courtyard gallery via a new glass door and sidelite.

The new exterior paneling was designed to highlight the north facing windows that flood light into the adjoining spaces.

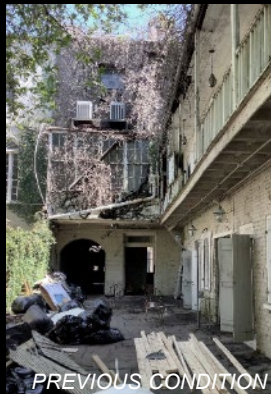
PREVIOUS CONDITION

Though covered in vegetation on the exterior, there were great vistas into the courtyard and worth re-imagining.

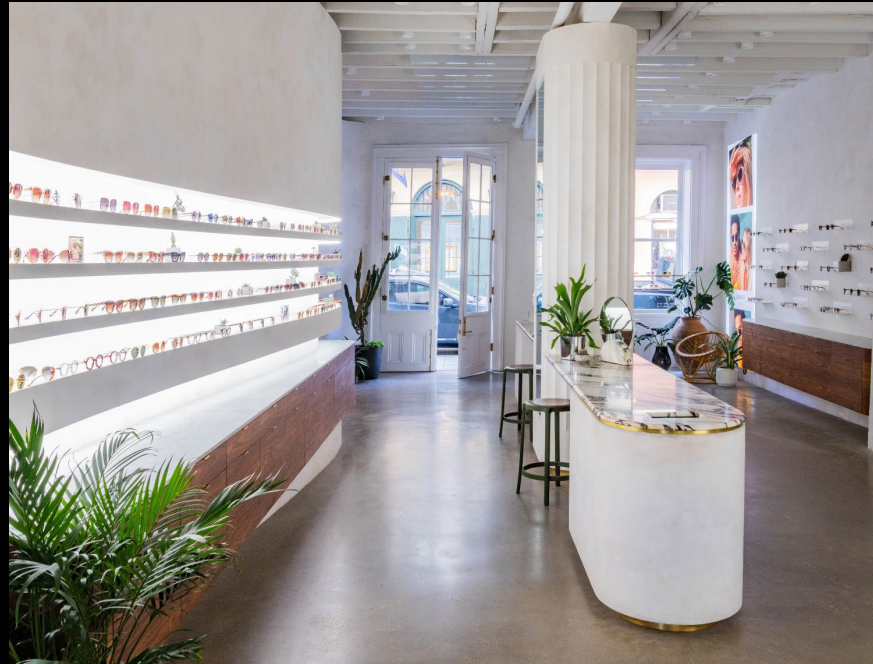
- The curve plaster walls provide movement along the path to the stairs and courtyard and hold the mechanical systems.
- The existing column is utilized as a focal point and workspace.
- Lighting is placed within the exposed wood beams, which were painted white as a fresh canvas to the tenant's vision.
- New concrete floors to reflect light deep into the space.

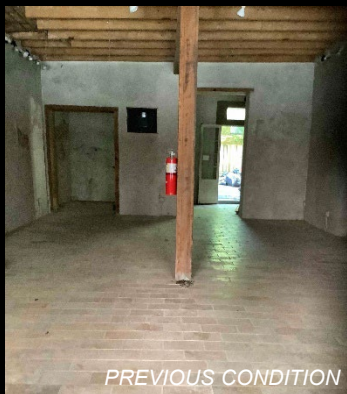
PREVIOUS CONDITION

Though previously used for commercial retail, the 1st floor was sleepy, equipped with outdated building systems, and disconnected from the rest of the building.

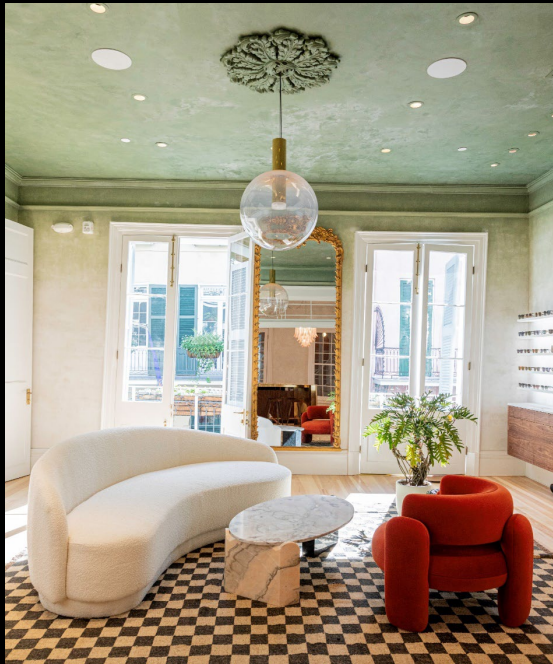
- The walls remain unlevel, but the millwork was adjusted to acknowledge the condition and provided a subtle modern detail.
- Restored plaster walls feel raw and aged with replica moldings.
- New bleached floors from the stairwell continue into the parlor.
- The walls pay homage the original green paint in the parlor with a modern ombre progression to the ceiling.
- Plaster medallions showcase modern light fixtures.

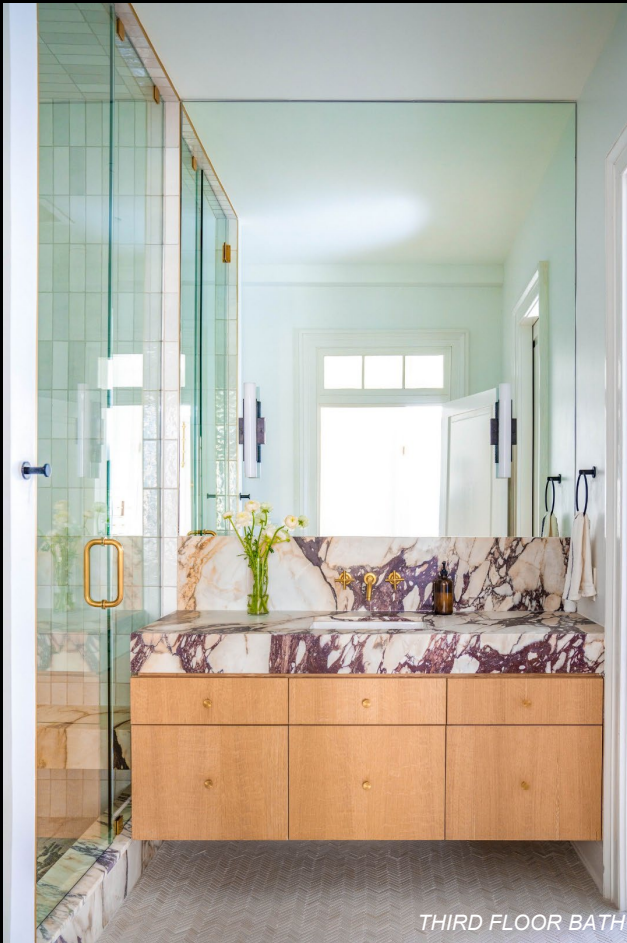
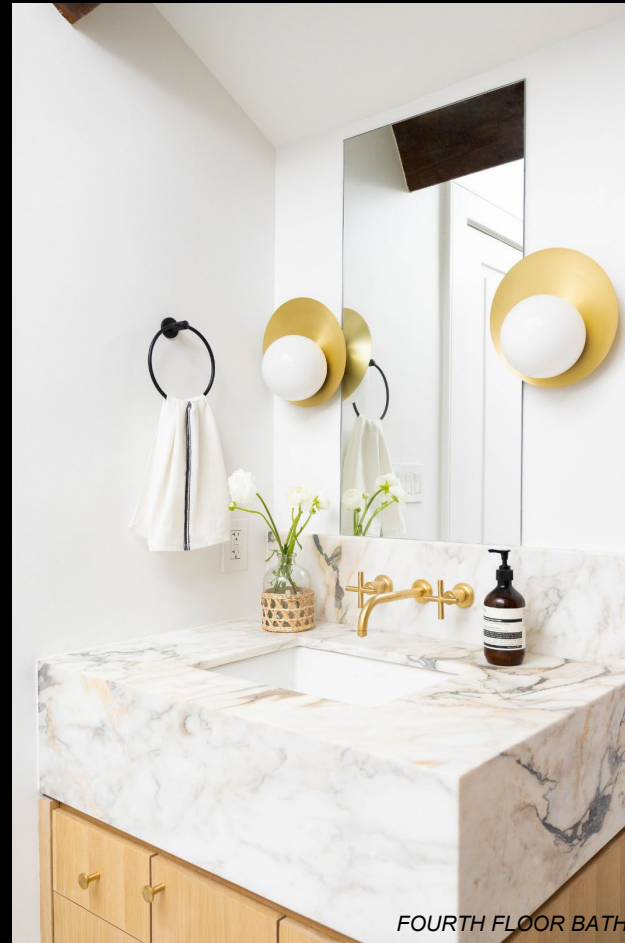
Beautiful slabs of marble provide bold statement with a thickened edge and exaggerated backsplashes.

Delicate brass knobs and wall mounted faucet play off the warm tones of the stone.

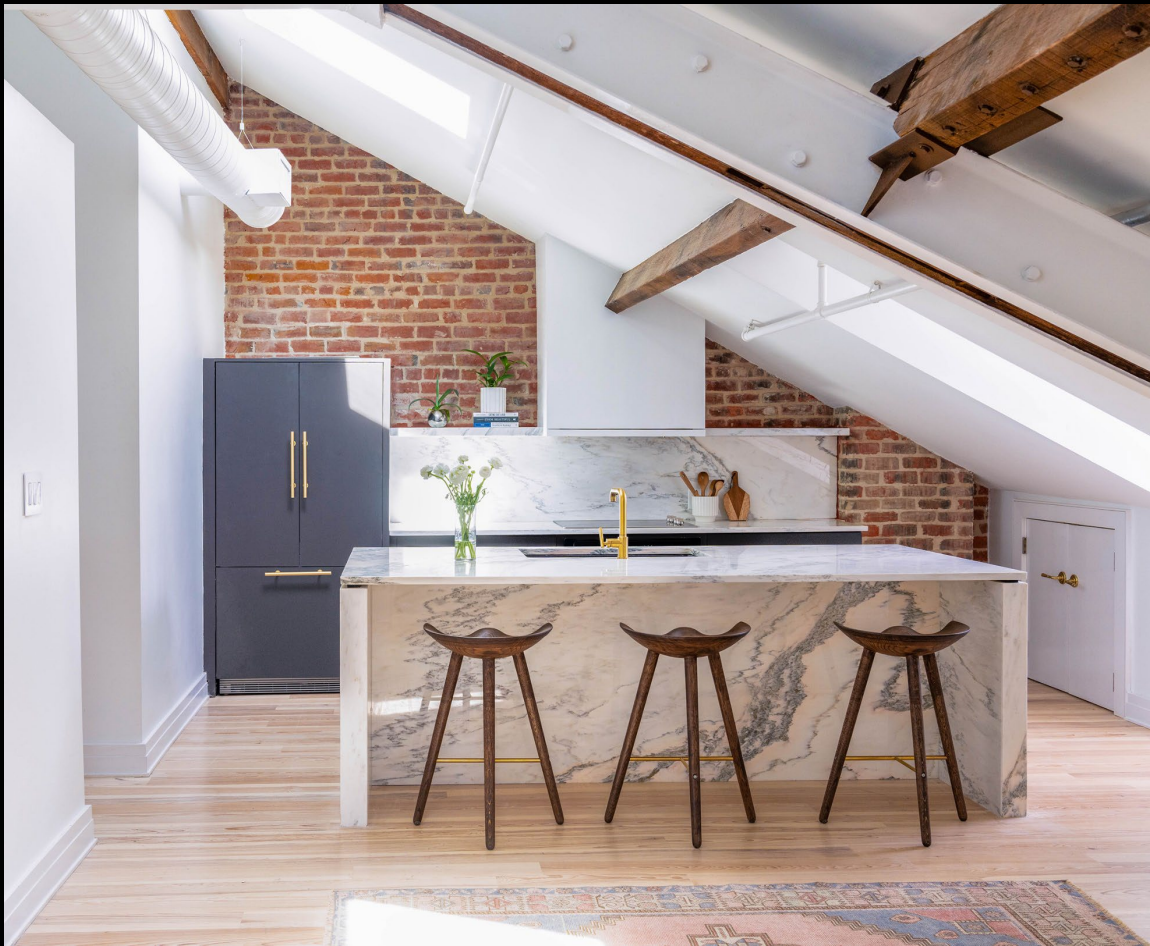
This provides the background for a striking, monolithic kitchen marble island which is the focal point of the living space.

Floating shelves, custom fitted appliances, seamless charcoal cabinets, and simply clad hoods blend into the background to showcase the marble backsplashes.

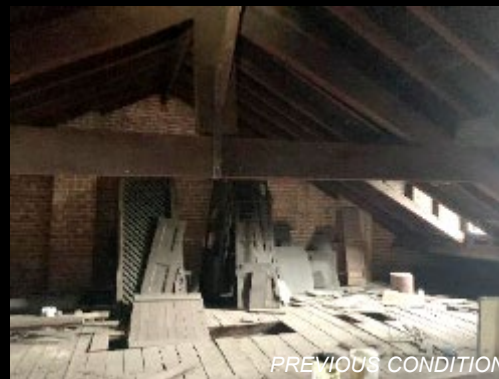
PREVIOUS CONDITION

The 4th floor, which was previously an attic space, includes new skylights and restored dormers and windows that visually open the space, along with limited new walls.

Crisp sheetrock ceilings with exposed beams brings the height of the attic while the exposed brick grounds the space.
